Manhole Inspection Summary

Manhole # S47EE_038MH

Insp Date: **7/16/08 1:23 PM**

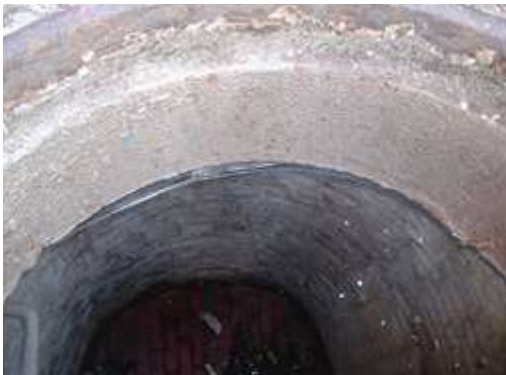
Defect 1

infiltration

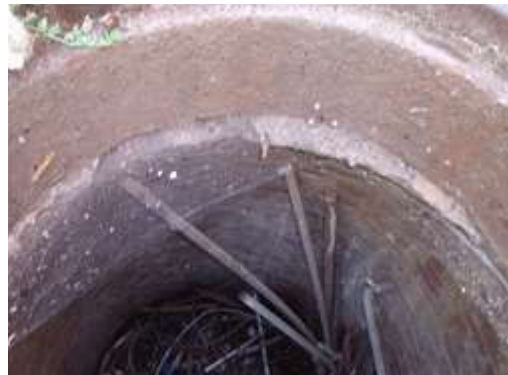
Defect 2

frame leaks; offset frame

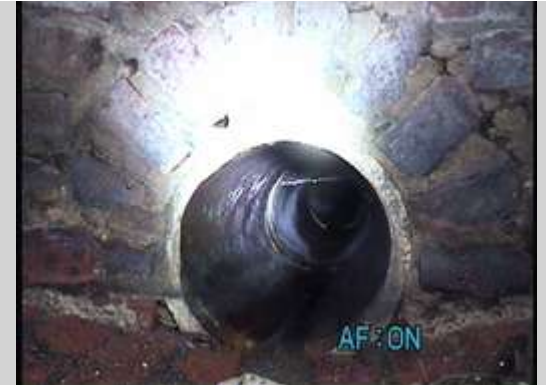
12 O'Clock Outflow

8 in. Circular Gravity Sewer
Pipe Out @ 12 O'Clock

Infiltration: **None** Pipe Seal Cond: **Sound**
